Wilmington School & Residence
Sound Attenuation Program

Report #4: Property Inventory and Mitigation Recommendations Report

Rev. April 21, 2016
L&B Project #532201-0300

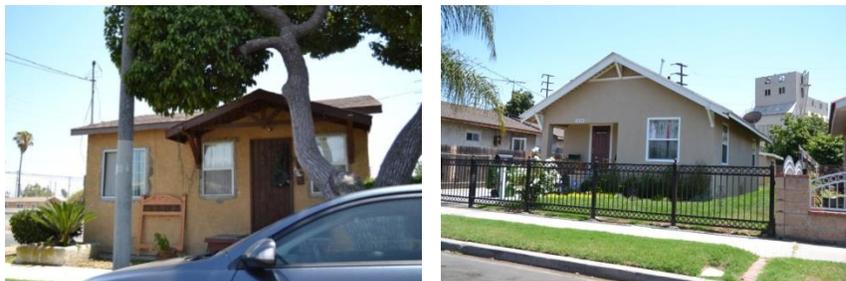
This site contains both single- and multi-family residential. The housing conditions vary with some homes requiring minor repair to major repair. The streets and sidewalks are in fair condition. Housing in this area has units in small to medium size lots with very few two-story large homes. The maintenance issues found in this area include unkempt vegetation, litter in yards, deteriorated walkways, or deteriorated fencing. Some lots may have more serious issues, such as inoperable vehicles occupying the lot.

Unpermitted conditions: Potential code and occupancy violations were observed in the study area.

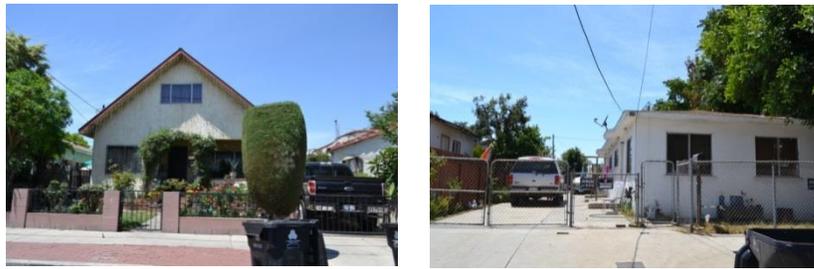
This site contains both single- and multi-family residential. The housing conditions vary with some homes requiring minor repair to major repair. The majority of these lots are poorly maintained. The streets and sidewalks are in fair condition. Housing in this area has units in small to medium size lots with very few two-story homes. Landscaping in this particular area is in need of repair. Some of the neighborhoods are industrial in character, with residential use abutting industrial.

Unpermitted conditions: Potential code and occupancy violations were observed in the study area.
