Wilmington School & Residence
Sound Attenuation Program

Report #4: Property Inventory and Mitigation Recommendations Report

Rev. April 21, 2016
L&B Project #532201-0300

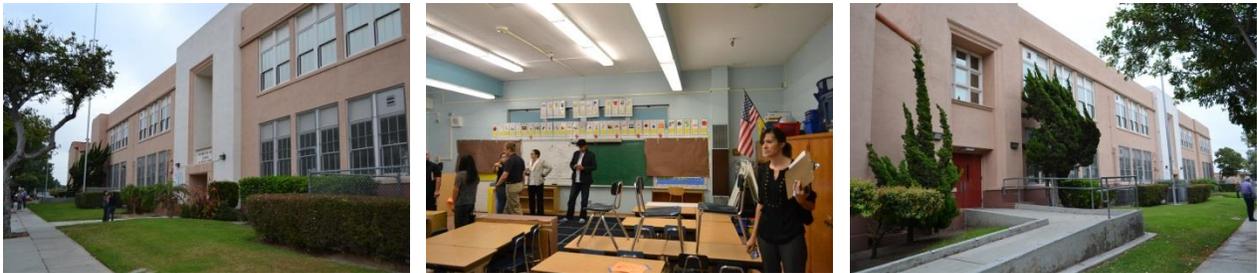
Structure A - The primary structure, and the oldest, is highlighted in blue on Figure 4. The building flanks Mahar Avenue on the west and is a two-story stucco structure with classrooms abutting interior access corridors. The primary window type is wood double-hung. No classrooms have doors that directly access the exterior of the building. Ventilation is provided by a mix of ductless-split and exterior mounted thru-wall systems. Photos of Structure A are included below.

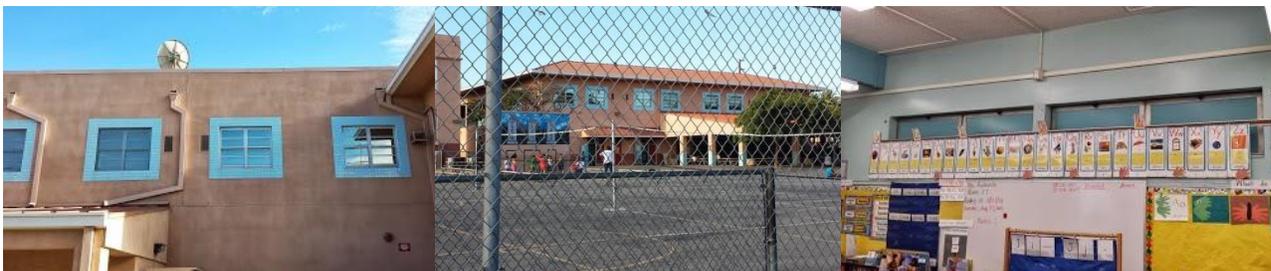
Structure B – The second structure evaluated is highlighted in orange in Figure 4 and flanks Blinn Avenue to the east. The building is a two-story stucco structure with the first floor functioning as teacher’s lounge, cafeteria, and assembly/gym. The second floor consists of classrooms abutting interior access corridors. The primary window type is wood double-hung. No classrooms have doors that directly access the exterior of the building. Ventilation is provided by rooftop mounted ventilation systems. Photos of Structure B are included below.

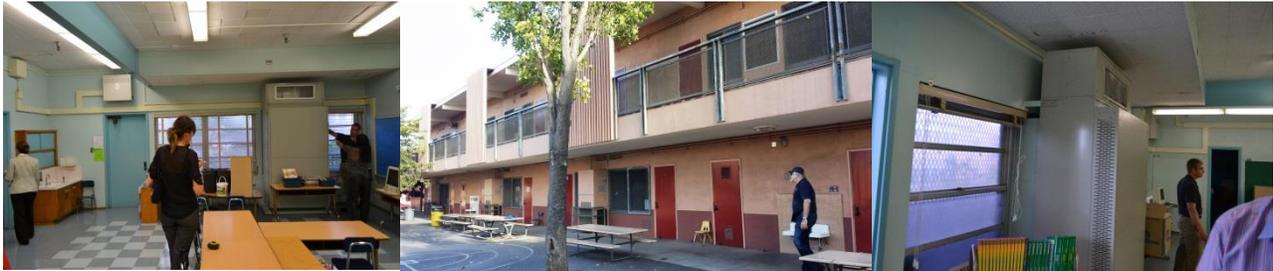
Structure C – The third structure evaluated is highlighted in green in Figure 4 and flanks Blinn Avenue to the east. The building is a two-story stucco structure with classrooms on both floors. All classrooms ingress and egress to exterior access corridors. The primary window type is wood double-hung. All have doors that directly access the exterior of the building. Ventilation is provided by exterior mounted thru-wall systems on first floor, and interior mounted systems on second floor. Photos of Structure C are included below.

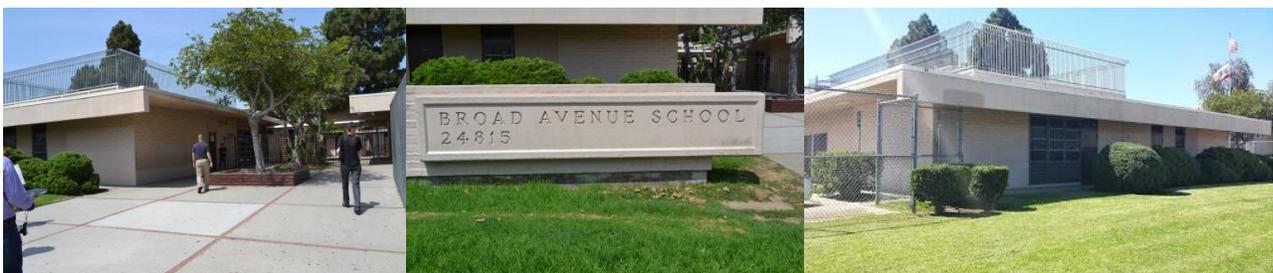
Structure A - The primary structure fronting Broad Avenue is highlighted in blue on Figure 5. The building is a single-story stucco structure serving the administrative functions of the school. The primary window type is aluminum fixed/awning arrays. Ventilation is provided by rooftop mounted ventilation systems. Photos of Structure A are included below.

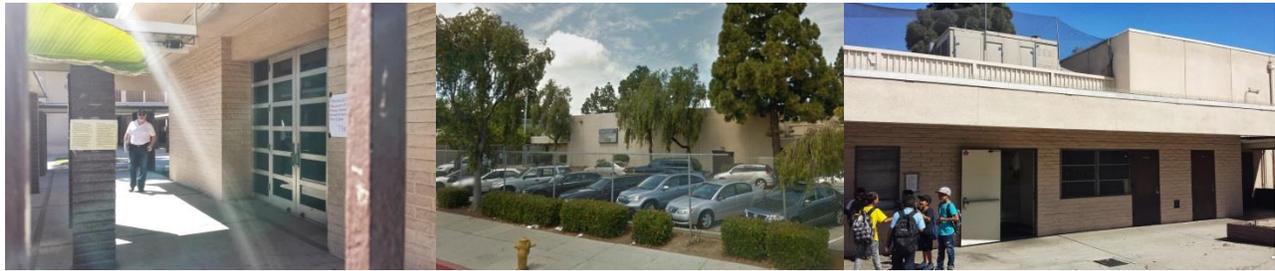
Structure Group B - The secondary structures fronting Broad Avenue are highlighted in orange on Figure 5. The buildings are a single-story stucco structures functioning as teacher's lounge, cafeteria, and assembly/gym. The primary window type is aluminum fixed/awning arrays. Ventilation is provided by rooftop mounted ventilation systems. Photos of Structure Group B are included below.

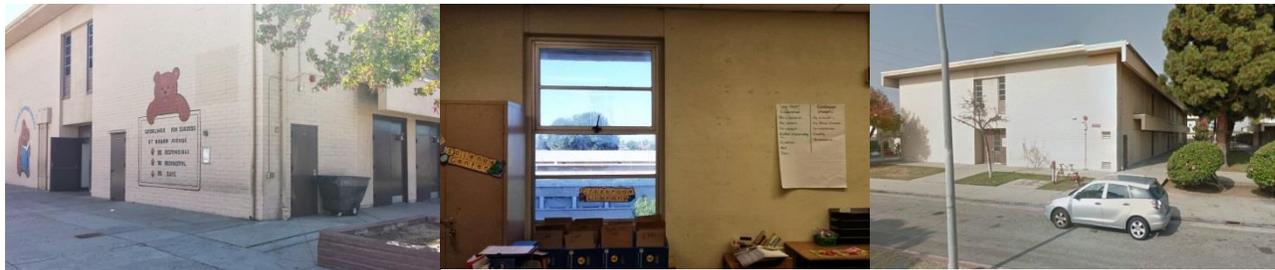
Structure Group C – Structure Group C runs perpendicular to E. 249th Street and is highlighted in green on Figure 5. These two structures are two-story classroom buildings clad in stucco. Classrooms abut interior access corridors. The primary window type is aluminum fixed/awning arrays. No classrooms have doors that directly access the exterior of the building. Ventilation is provided by rooftop mounted ventilation systems. Photos of Structure Group C are included below.

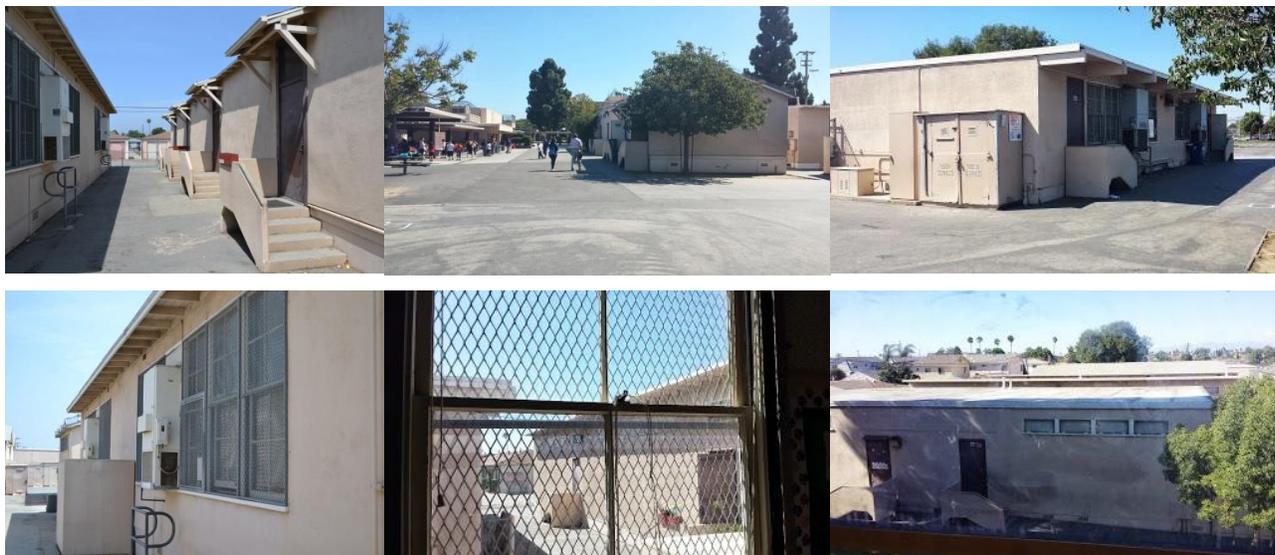
Structure Group D – Structure Group D represents the modular structures and is highlighted in yellow. The buildings are single-story stucco structures. All classrooms ingress and egress to the exterior. The primary window type is wood double-hung. All have doors that directly access the exterior of the building. Ventilation is provided by exterior mounted thru-wall systems. Photos of Structure Group D are included below.

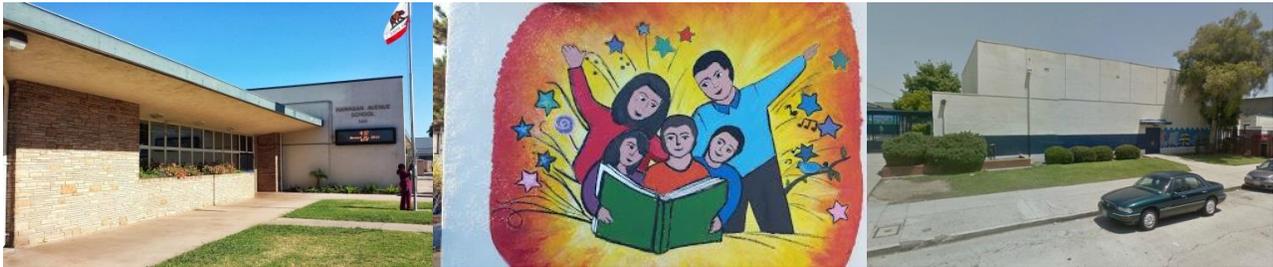
Structure Group A – Structure Group A fronting Hawaiian Avenue is highlighted in orange on Figure 7. The building to the north is a single-story stone veneer and stucco structure serving the administrative functions of the school. The structure to the south is a stucco building and serves as the cafeteria and assembly for the school. The primary window type is aluminum fixed/awning arrays. Ventilation is provided by rooftop mounted ventilation systems. Photos of Structure Group A are included below.

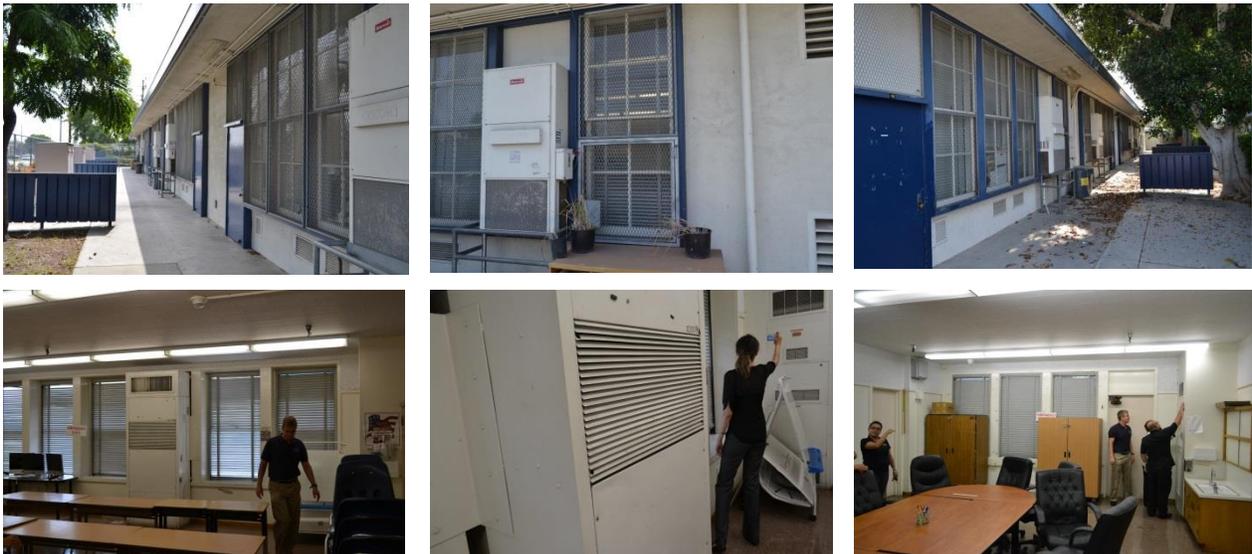
Structure Group B – Structure Group B fronting Hawaiian Avenue to the west and W. F Street to the north and are highlighted in green on Figure 7. The buildings are single-story stucco structures and house classrooms abutting a central access corridor. The primary window type is wood double-hung. Many classrooms have doors that directly access the exterior of the building. Ventilation is provided by thru-wall mounted ventilation systems. Photos of Structure Group B are included below.

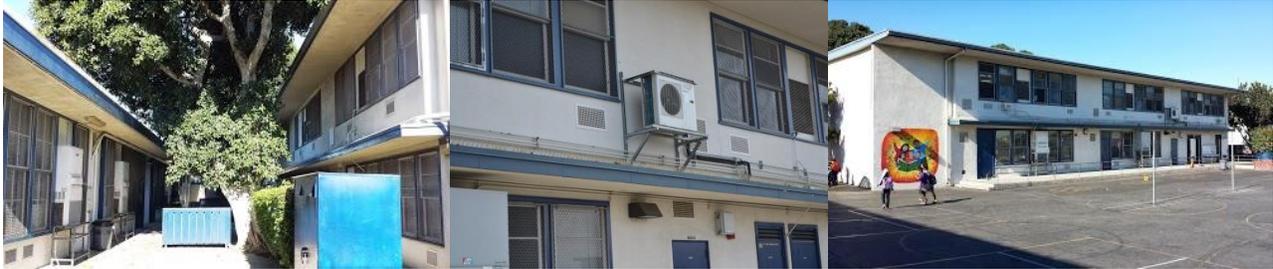
Structure C – Structure C is located in the northern part of the courtyard and is highlighted in blue on Figure 7. The building is a two-story stucco structure and house classrooms abutting a central access corridor. The primary window type is wood double-hung. Classrooms have doors that directly access the exterior of the building on the first floor. The second floor classrooms egress to an interior access corridor. Ventilation is provided by thru-wall mounted ventilation systems. Photos of Structure Group C are included below.

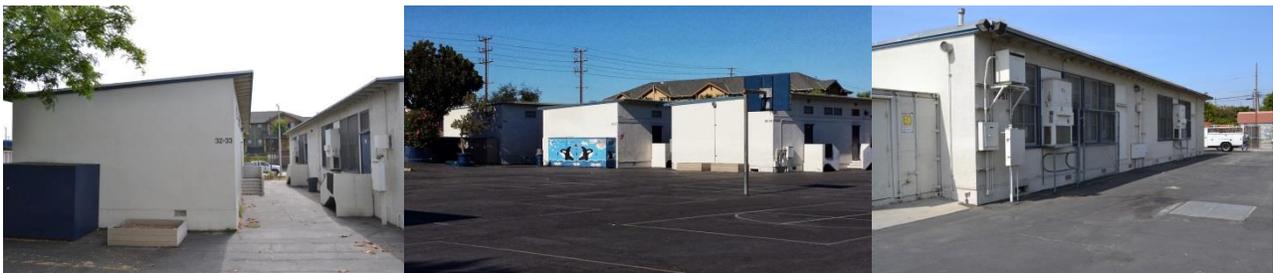
Structure Group D – Structure Group D represents the modular structures and is highlighted in yellow and red. The red structures are no longer on site and have been removed since the aerial imagery has been taken. The buildings in yellow are single-story stucco structures. All classrooms ingress and egress to the exterior. The primary window type is wood double-hung. All have doors that directly access the exterior of the building. Ventilation is provided by exterior mounted thru-wall systems. Photos of Structure Group D are included below.

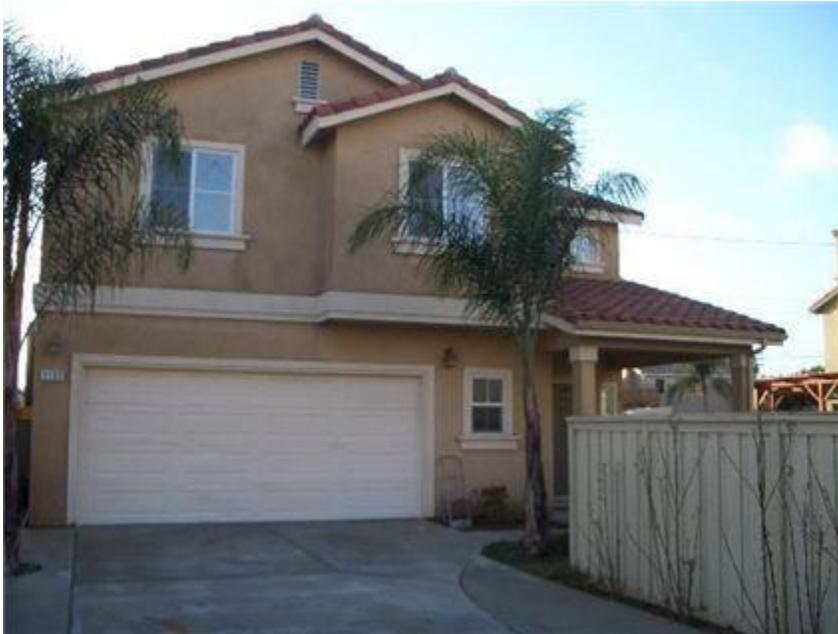
This property was not identified in the primary and alternate lists identified in Table 2. The property is a neighbor of the listed homes and shares the same attributes. The home is in good repair and condition and represents the Neo-Mediterranean Style. It is located on the

McFarland Rail Line and in the Hyatt Avenue/ Alameda Street Study Area. A building photo and site/building attributes are presented below. A building floor plan is presented in Figure 8.

3. **Wall system (materials, form, construction and access):** This home is clad in stucco, likely over ½" GSB with 2"x4" wood or aluminum studs. The interior of the wall assembly is finished with ½" wallboard with textured plaster. The walls are likely insulated though there was no access to the wall cavity to verify.
4. **Windows and glazing systems (materials, form and construction):** Most windows were vinyl double-hung sash windows of a standard size. The upstairs windows were sliders. Glazing in the windows was insulated.

5. **Ventilation characteristics:** This house relies on windows and/or a forced-air HVAC system for ventilation. The HVAC system provides heating and cooling.
6. **Constructability issues for noise mitigation:** Access to site is not an issue. There is no debris that would prevent a workforce from installing noise mitigation treatments. The home already has a mechanical ventilation system that would allow homeowner to seal up house to take advantage of treatments in comfort. Windows are flanged mounted and set in exterior stucco wall. Replacement would require cutting back siding, adding new waterproofing, patching and painting. The same would be true for the interior surfaces.

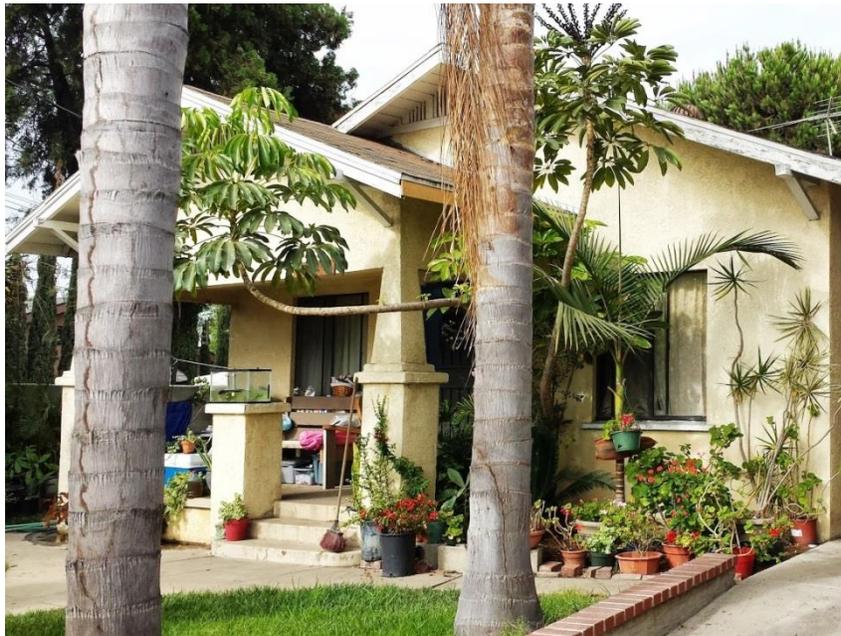
933 McFarland Avenue – Assessment Visit Tuesday 8/27/13 @ 9:00 a.m.

The home is in fair repair and condition represents the Bungalow Style. It is located on the McFarland Rail Line and is in the Hyatt Avenue/Alameda Street Study Area. A building photo and site/building attributes are presented below. A building floor plan is presented in Figure 9.

The homeowner was interviewed about the noise environment. The primary nuisance as defined by homeowner was found to be nighttime rail noise with a particular nuisance to be the train horn.

4. **Windows and glazing systems (materials, form and construction):** Most windows were metal casement windows of a standard size. Windows were single-glazed.

5. **Ventilation characteristics:** This house relies on windows for ventilation. There is no mechanical means of ventilation at the property.
6. **Constructability issues for noise mitigation:** Access to site is not an issue. There is no debris that would prevent a workforce from installing noise mitigation treatments. The property does not have a mechanical ventilation system that would allow homeowner to seal up house to take advantage of treatments in comfort. Windows are flanged mounted and set in exterior stucco wall. Replacement would require cutting back siding, adding new waterproofing, patching and painting. The same would be true for the interior surfaces. The bedroom addition to the rear of the house barely meets minimum size requirements for habitability required by code.

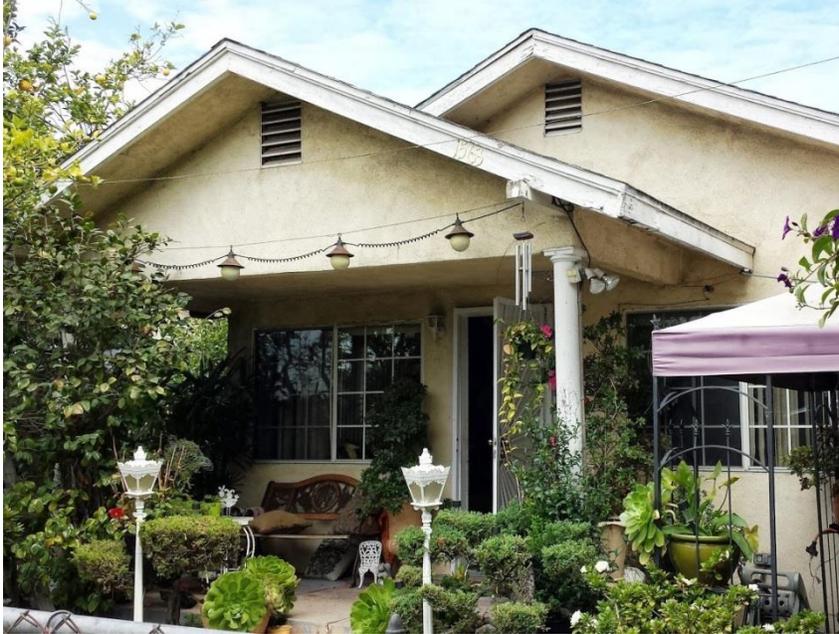
1563 East L Street – Assessment Visit Tuesday 8/27/13 @ 11:00 a.m.

The home is in fair repair and condition represents the Bungalow Style, and is located on the Alameda Boulevard Rail Line and is in the Hyatt Avenue/ Alameda Street Study Areas. A building photo and site/building attributes are presented below. A building floor plan is presented in Figure 10.

The homeowner was interviewed about the noise environment. The primary nuisance as defined by homeowner was found to be nighttime rail noise with the train horn being the major nuisance.

- 3. Wall system (materials, form, construction and access):** This home is clad in stucco, likely over ½" board lumber and 2"x4" wood studs. The interior of the wall assembly is finished with textured plaster. The walls are likely insulated though there was no access to the wall cavity to verify.

4. **Windows and glazing systems (materials, form and construction):** Most windows were metal sliding windows of a standard size. Windows were single-glazed.

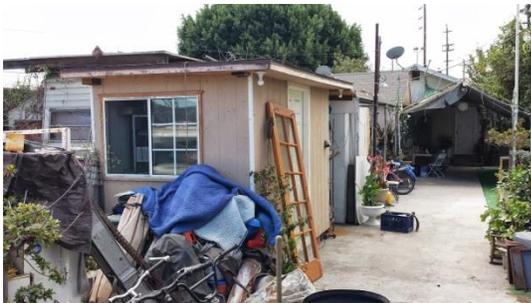
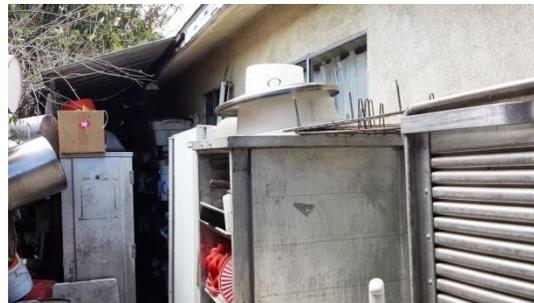
5. **Ventilation characteristics:** This house relies on windows for ventilation. There is no mechanical means of ventilation at the property.
6. **Constructability issues for noise mitigation:** Access to site is an issue as it is littered with debris and a narrow setback from the junk car lot (see photos below). Furnishings completely fill the bedrooms limiting access to windows from the interior. This limited access would inhibit the installation of noise mitigation treatments. The property does not have a mechanical ventilation system that would allow homeowner to seal up house to take advantage of treatments in comfort. Windows are flanged mounted and set in exterior stucco wall. Replacement would require cutting back siding, adding new waterproofing, patching and painting. The same would be true for the interior surfaces.

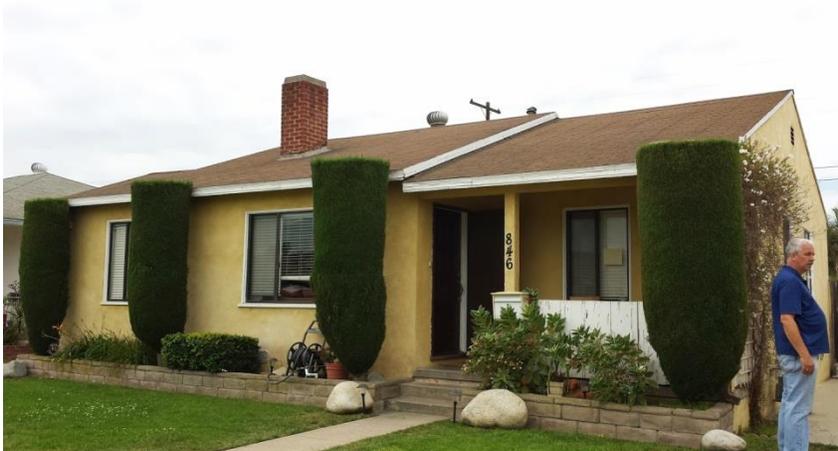
846 Oceanside Street – Assessment Visit Tuesday 8/27/13 @ 12:00 noon

The home is in good repair and condition represents the Ranch Style. It is located on the Northern Rail Line and is in the Broad Avenue/Oceanside Street Study Areas. A building photo and site/building attributes are presented below. A building floor plan is presented in Figure 11.

The homeowner was interviewed about the noise environment. The primary nuisance as defined by homeowner was found to be nighttime rail noise, particularly the train horn.

6. **Constructability issues for noise mitigation:** Access to site is not an issue. There is no debris that would prevent a workforce from installing noise mitigation treatments. The home already has a mechanical ventilation system that would allow homeowner to seal up house to take advantage of treatments in comfort. Windows are flanged mounted and set in exterior stucco wall. Replacement would require cutting back siding, adding new waterproofing, patching and painting. The same would be true for the interior surfaces. One bedroom in the home has an abandoned door to the exterior that has been walled over to the interior.

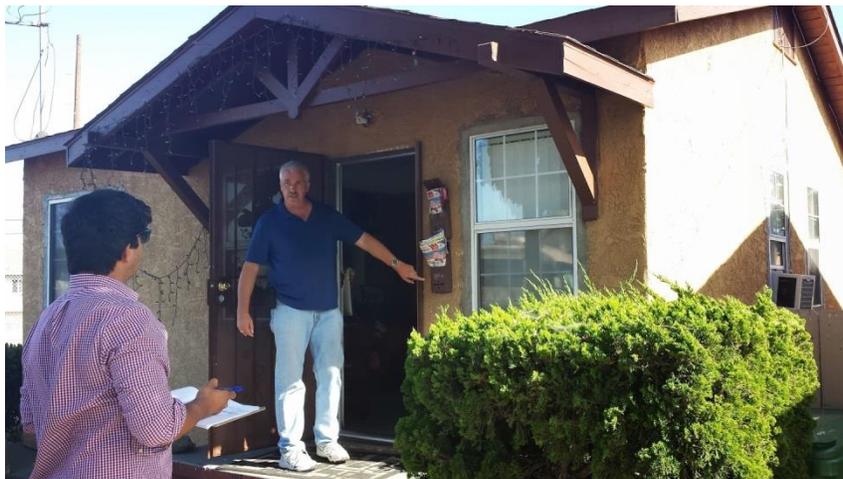
1534 East Denni Street – Assessment Visit Tuesday 8/27/13 @ 4:00 p.m.

The home is in fair repair and condition represents the Bungalow Style, and is located on the Alameda Boulevard Rail Line and is in the Hyatt Avenue/Alameda Street Study Area. A building photo and site/building attributes are presented below. A building floor plan is presented in Figure 12.

The occupants of the property were interviewed about the noise environment. The primary nuisance as defined by occupants was found to be nighttime rail noise, particularly the train horn.

- Windows and glazing systems (materials, form and construction):** Most windows were vinyl replacement windows of a standard size. Windows were single-glazed.

- Ventilation characteristics:** This house relies on windows for ventilation. There is no mechanical means of ventilation at the property.
- Constructability issues for noise mitigation:** Access to the site is not an issue. Furnishings completely fill the bedrooms limiting access to windows from the interior. This limited access would inhibit the installation of noise mitigation treatments. The property does not have a mechanical ventilation system that would allow homeowner to seal up house to take advantage of treatments in comfort. Windows are flanged mounted and set in exterior stucco wall. Replacement would require cutting back siding, adding new waterproofing, patching and painting. The same would be true for the interior surfaces. There are signs of occupancy violations in the non-residential structures flanking Alameda Street.

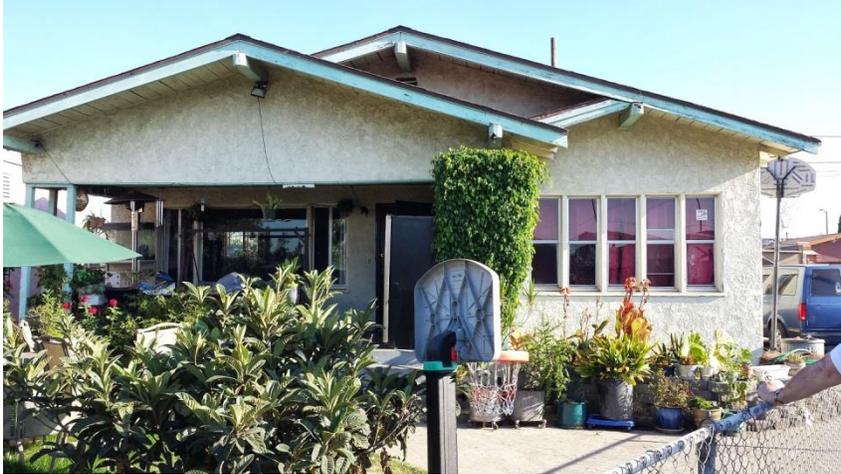
1559 East O Street – Assessment Visit Wednesday 8/28/13 @ 8:00 a.m.

The home is in good repair and condition represents the Bungalow Style, and is located on the Drumm Street/Sanford Street/Opp Street truck routes and is in the Drumm Street Study Area. A building photo and site/building attributes are presented below. A building floor plan is presented in Figure 13.

The homeowner was interviewed about the noise environment. The primary nuisance as defined by homeowner was found to be truck traffic 24 hours a day.

3. **Wall system (materials, form, construction and access):** This home is clad in stucco, likely over ½” board lumber and 2”x4” wood studs. The interior of the wall assembly is finished with textured plaster. The walls are likely insulated though there was no access to the wall cavity to verify.

4. **Windows and glazing systems (materials, form and construction):** Most windows were aluminum double-hung of a standard size. Windows were single-glazed.

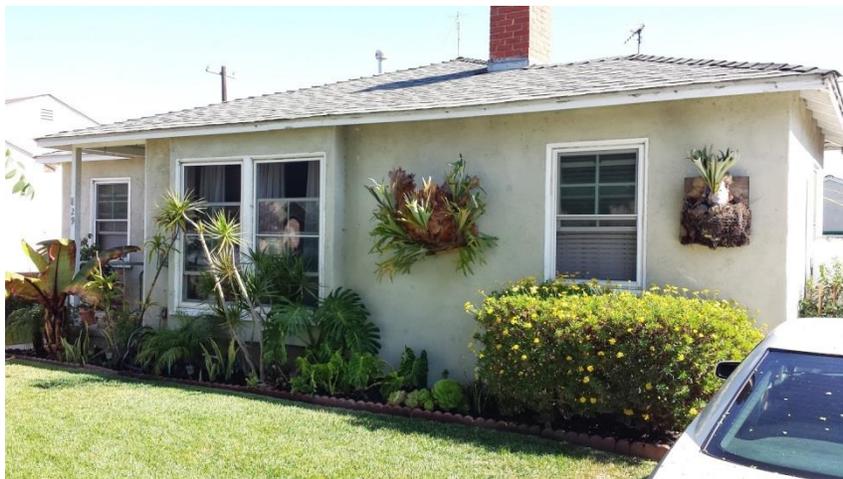
The home is in good repair and condition represents the Ranch Style. It is located on the Northern Rail Line and is in the Broad Avenue/Oceanside Street Study Areas. A building photo and site/building attributes are presented below. A building floor plan is presented in Figure 14.

1. **Main characteristics:** This home is wood framed, clad in stucco, with an asphalt shingle roof. The main house form is based on a rectangular plan with a gabled roof. A detached garage is located at the rear of the property. The sleeping areas are to the left and right sides of the house. The rear of the home accesses a patio through a swinging door off the kitchen. Houses built in this era are typically un-insulated. The age of the house will likely have a negative impact on the buildings performance given it was built in an era with less stringent building requirements.
2. **Noise orientation:** This home flanks the Northern Rail Line to rear of the property. A five-foot high block wall, and a portion of the detached garage separate the property from the rail line. The living spaces line-of-sight to the noise source is obstructed by the masonry wall and garage.

The homeowner was interviewed about the noise environment. The primary nuisance as defined by homeowner was found to be nighttime rail noise and in particular the train horn.

6. **Constructability issues for noise mitigation:** Access to site is not an issue. There is no debris that would prevent a workforce from installing noise mitigation treatments. The home already has a mechanical ventilation system that would allow homeowner to seal up house to take advantage of treatments in comfort. Windows are flanged mounted and set in exterior stucco wall. Replacement would require cutting back siding, adding new waterproofing, patching and painting. The same would be true for the interior surfaces. Bedrooms were observed to have exterior locks on every bedroom which suggest home may be functioning as a group home (illegal use).

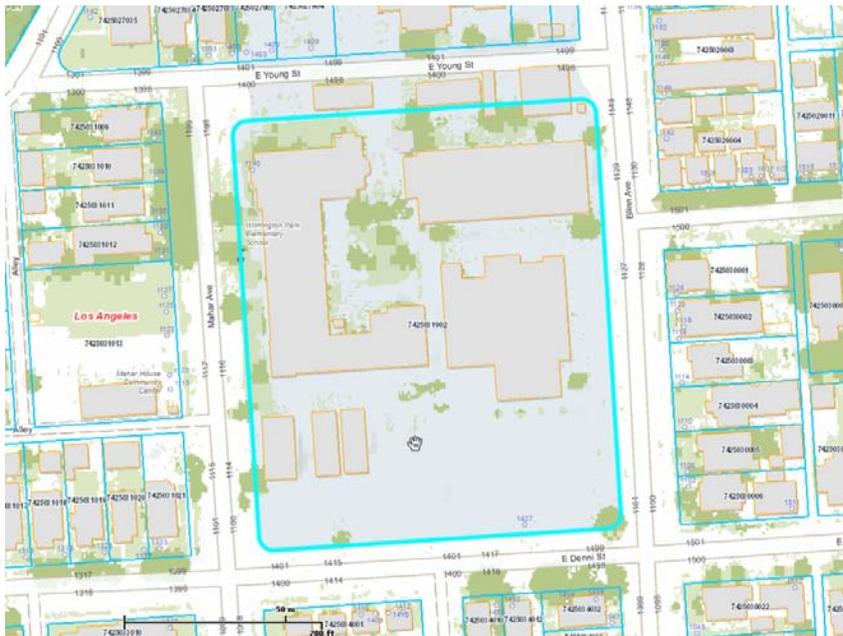
Wilmington Park Elementary School – Assessment Visit Tuesday 8/27/13 @ 5:00 p.m.

The Wilmington Park Elementary School is located at 1140 Mahar Street and is one of 673 elementary schools in Los Angeles Unified School District. It is a public school that serves 973 students in grades K-5. The school resides on a 3.69 acre lot bounded by Young Street to the north, Blinn Avenue to the East, Denni Street to the south, and Mahar Avenue to the west. The school is in good repair and condition and is located in the Hyatt Avenue/Alameda Street Study Area. A building layout and site/building attributes are presented below. Typical classroom layouts are presented in Figure 15.

3. **Typical classroom wall system (materials, form, construction and access):** The wall assemblies of all structures are all clad in stucco. The interior of the wall assemblies are finished with sheetrock. All wall cavities are at least 3½". Determination of insulation in wall cavities was not possible.

4. **Typical classroom door/windows and glazing systems (materials, form and construction):** Majority of windows are wood single-glazed double-hung in fair to good condition. Doors to classrooms are wood solid-core.
5. **Typical classroom ventilation characteristics:** Ventilation systems are predominantly exterior wall-mounted heat pumps for classrooms on the ground floor. Second floor systems vary from interior thru-wall mounted units to rooftop mounted units.

Constructability issues for noise mitigation: Window and door installations would not require major cutting and patching. Replacement of ventilation systems would trigger the need to perform environmental testing for lead-paint and asbestos. Implementing improvements would require, at minimum, coordination with LAUSD and the Division of the State Architect.

Of note, a review of an inspection report dated 6/07/13 performed by the Office of Environmental Health and Safety identified ongoing HVAC problems at the facility (deficiency ID 156305). The LAUSD was identified as the responsible party with the status of the issue being identified as open.

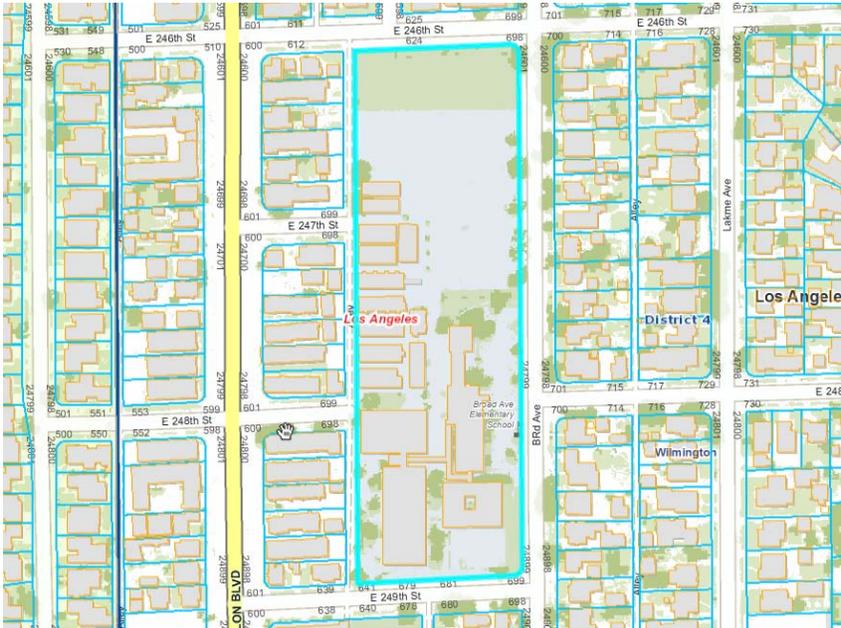
The Broad Avenue Elementary School is located at 24815 Broad Avenue and is one of 673 elementary schools in Los Angeles Unified School District. It is a public school that serves 826 students in grades K-5. The school resides on a 5.83 acre lot bounded by 245th Street to the north, Broad Street to the East, 249th Street to the south, and an alley to the west. The school is in good repair and condition and is located in the Broad Avenue/Oceanside Street Study Area. A building layout and site/building attributes are presented below. Typical classroom layouts are presented in Figure 16.

1. **Main characteristics:** The Broad Avenue Elementary School consists of four permanent structures and eleven modular structures. All buildings are clad in stucco with flat or low-pitched roofs. The main buildings vary between single- and two-story structures, while the modular buildings are all single-story.
2. **Noise orientation:** The school properties eastern boundaries are located 900 to 1000 feet from the Northern Rail Line. Residential housing to the north and east of the property obstructs the line of site to the noise source.

The Principal and teachers were interviewed about the noise environment. Interviews revealed that the rail noise was not considered a nuisance.

- 4. Typical classroom door/windows and glazing systems (materials, form and construction):** Majority of windows are aluminum awnings in the main buildings, and wood single-glazed double-hung in the modular structures. All are in fair to good condition. Doors to classrooms are wood solid-core. Clearstory windows in modular have no glazing and are in-filled with plywood.

- 6. Constructability issues for noise mitigation:** Window and door installations would not require major cutting and patching. Replacement of ventilation systems would trigger the need to perform environmental testing for lead-paint and asbestos. Implementing improvements would require, at minimum, coordination with LAUSD and the Division of the State Architect.

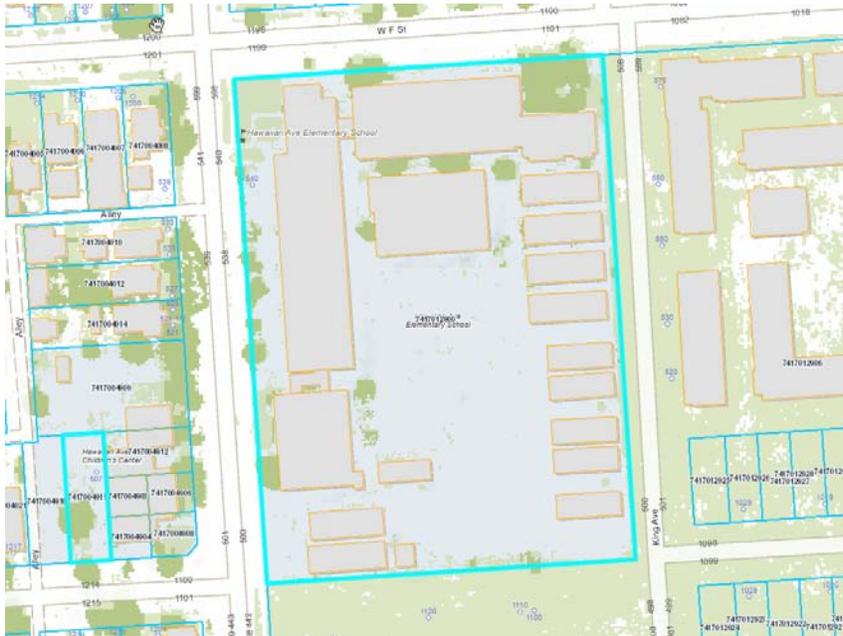
Hawaiian Avenue Elementary School – Assessment Visit Wednesday 8/28/13 @ 5:00 p.m.

The Hawaiian Avenue Elementary School is located at 540 Hawaiian Avenue and is one of 673 elementary schools in Los Angeles Unified School District. It is a public school that serves 927 students in grades K-5. The school resides on a 4.13 acre lot bounded by West F Street to the north, King Avenue to the East, D Court to the south, and Hawaiian Avenue to the west. The school is in good repair and condition and is located in the Hawaiian Avenue Study Area. A building layout and site/building attributes are presented below. Typical classroom layouts are presented in Figure 17.

The Principal and teachers were interviewed about the noise environment. Interview revealed that the TraPac noise was not considered a nuisance.

3. **Typical classroom wall system (materials, form, construction and access):** The wall assemblies of all structures are all clad in stucco. The interior of the wall assemblies for the main buildings are finished with sheetrock. All wall cavities are at least 3½". Determination of insulation in wall cavities was not possible.

4. **Typical classroom door/windows and glazing systems (materials, form and construction):** Majority of windows are wood single-glazed double-hung. All are in fair to good condition. Doors to classrooms are wood solid-core.

6. **Constructability issues for noise mitigation:** Window and door installations would not require major cutting and patching. Replacement of ventilation systems would trigger the need to perform environmental testing for lead-paint and asbestos. Implementing improvements would require, at minimum, coordination with LAUSD and the Division of the State Architect.
